YOUR VIRTUAL DISCOVERY VISIT – 73 TO THE HERITAGE STORIES OF ROTTNEST ISLAND

Anchors Aweigh Away

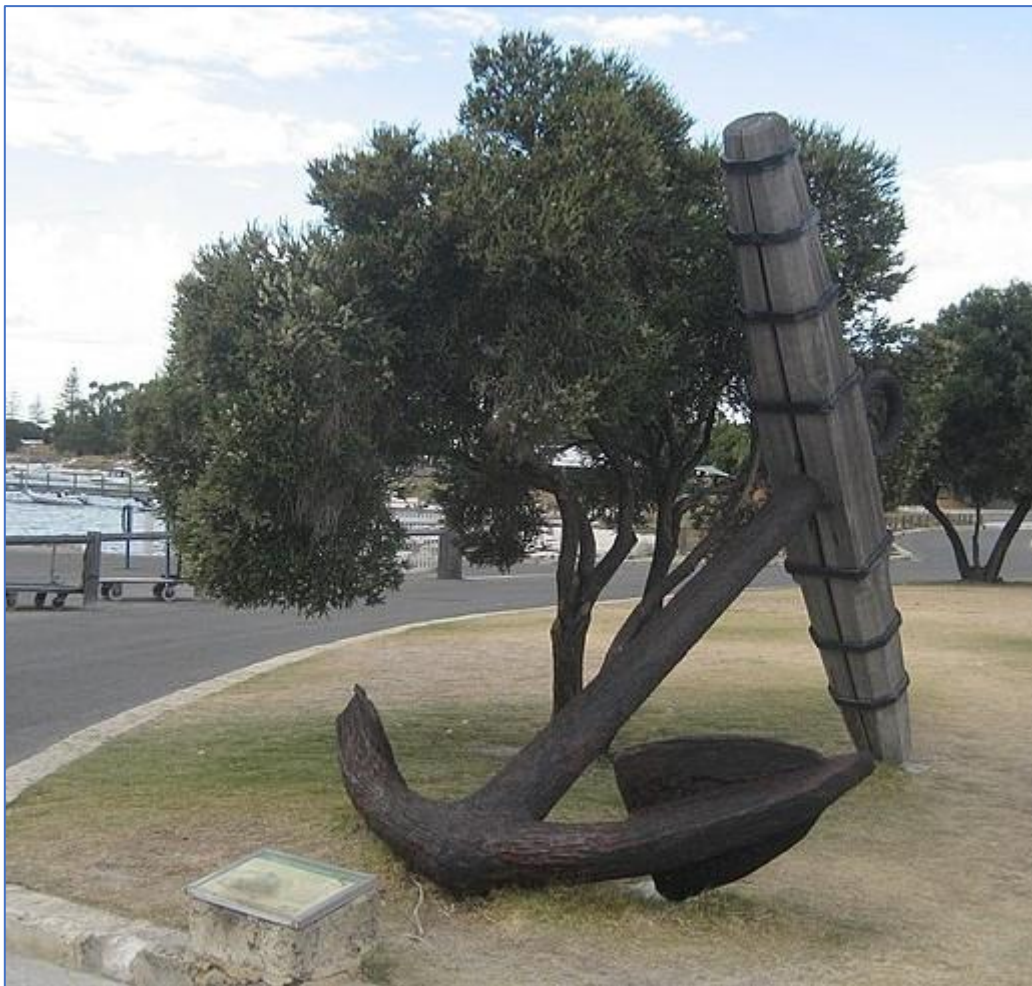
City of York anchor with wooden stock on Rottnest

The anchors are familiar to RVGA guides as reminders of the wrecks of the ***Mira Flores*** in 1886 and the ***City of York*** in 1899. Both are of the Admiralty Pattern known simply as an "Admiralty" or as a "Fisherman". This pattern of anchor consists of a central shank with a ring or shackle for attaching the rode (the rope, chain, or cable connecting the ship and the anchor). At the other end of the shank there are two arms, carrying the fluke. A wooden or metal stock is mounted to the shackle end, at ninety degrees to the arms.

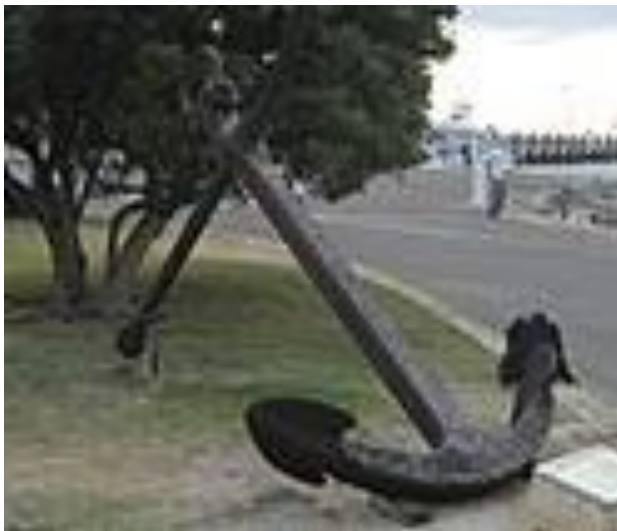
Mira Flores anchor with metal stock on Rottneest

When this type of anchor lands on the bottom, it will generally fall over with the arms parallel to the seabed. As a strain comes onto the rode, the stock will dig into the bottom, canting the anchor until one of the flukes catches and digs into the bottom. The Admiralty Anchor is an entirely independent reinvention of a classical design which has remained unchanged for centuries. Iron stocks began to replace wood in the late 1830s and early 1840s.

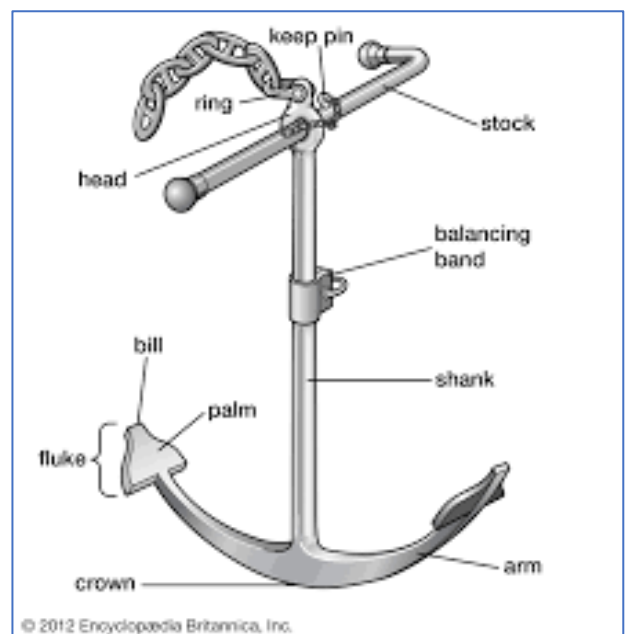
Handling and storage of this type of anchor required special equipment and procedures. Once the anchor was hauled up to the hawsepipe, the ring end had to be hoisted up to the end of a timber projecting from the bow known as the cathead.

The crown of the anchor is then hauled up with a heavy tackle until one fluke can be hooked over the rail. This is known as "catting and fishing" the anchor. Before dropping the anchor, the fishing process is reversed, and the anchor is dropped from the end of the cathead.

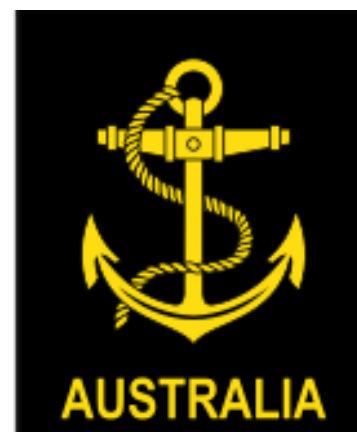
Since one fluke always protrudes up from the set anchor, there is a great tendency of the rode to foul the anchor as the vessel swings due to wind or current shifts. A fouled anchor is used by many of the world's navies as part of their badges or heraldry.

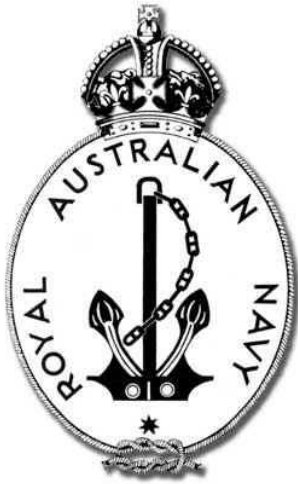
The stockless anchor, patented in England in 1821, represented the first significant departure in anchor design in centuries. Though their holding-power-to-weight ratio is significantly lower than admiralty pattern anchors, their ease of handling and stowage aboard large ships led to almost universal adoption.

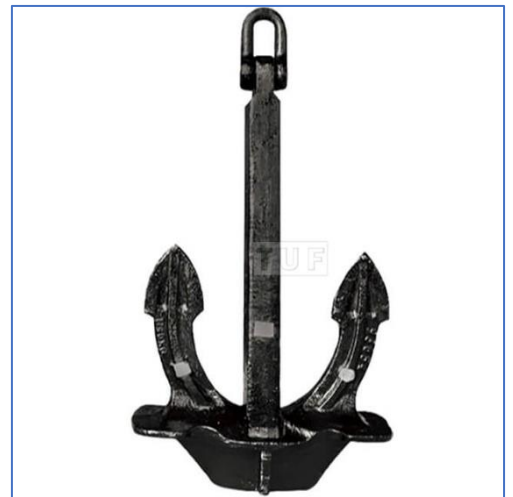
In contrast to the elaborate stowage procedures for earlier anchors, stockless anchors are simply hauled up until they rest with the shank inside the hawsepipes, and the flukes against the hull (or inside a recess in the hull).

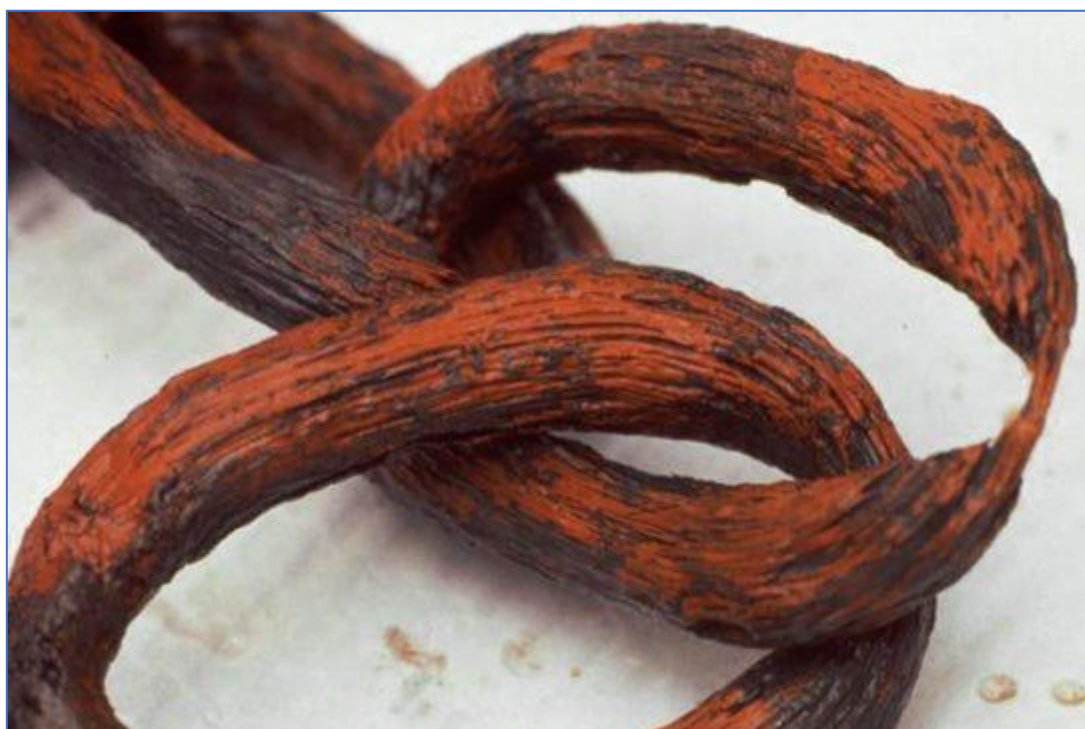
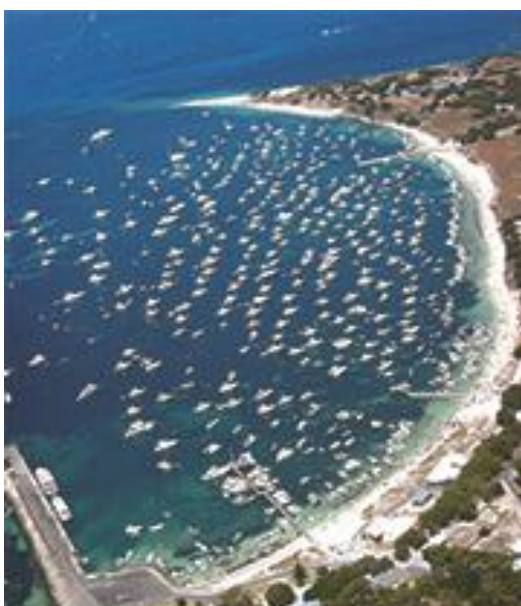
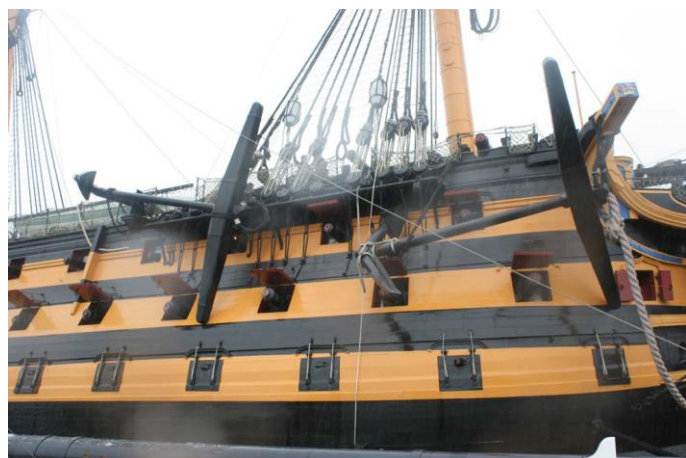
Next time you visit Rottnest have a closer look at the *Mira Flores* and *City of York* anchors. Relatively pure iron as found in old wrought iron articles with laminar or fibrous structure such as anchors or large anchor chain links is not brittle. What rusted away in the photo below was mostly the stringer inclusions, not the iron. The iron component of wrought iron is relatively corrosion resistant.

Anchors of HMS Victory “catted and fished”
